XPEDITE COATINGS PSC SYSTEM

LAKES OF PARKWAY
HOMEOWNERS ASSOCIATION

Over 100 potholes and spalled
concrete spots were repaired

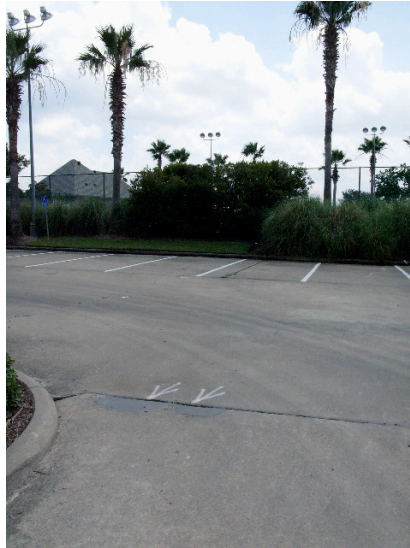
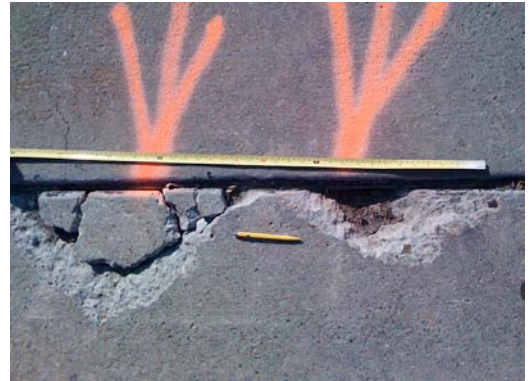
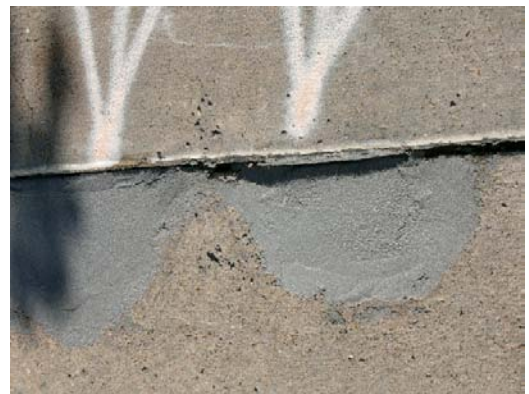
RIGHT AND BELOW

Once spalled concrete is cleared, the cavity to be filled becomes apparent. It is thoroughly cleaned and primed and then filled with 100% solid epoxy concrete designed to repair heavily damaged concrete with a quick turn-around. The product can be formed, molded or shaped making it ideal for curbs, damaged concrete and new construction. Compressive strength is 8,000 to 10,000 psi.
